## NASA TECHNICAL REPORT

NASA TR R-180

REACTIVITY OF TITANIUM WITH OXYGEN

by W. A. Riehl, C. F. Key, and J. B. Gayle George C. Marshall Space Flight Center Huntsville, Ala.

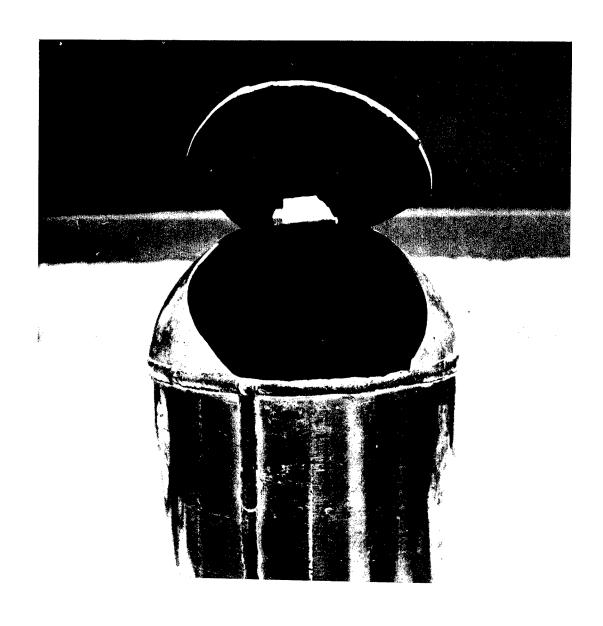
FIGURE 18. ALUMINUM TANK FAILURE IN PRESSURE TEST-0.063 IN. WALL

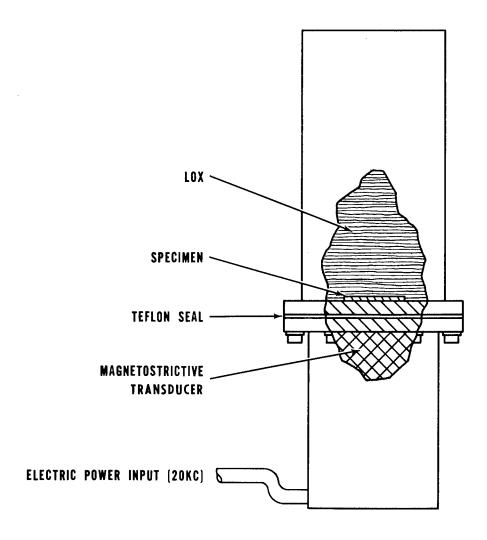
FIGURE 20. SCHEMATIC OF SET UP FOR DETERMINING EFFECT OF ULTRASONIC ENERGY ON LOX SENSITIVITY OF MATERIALS.

Titanium coupons were placed in LOX and subjected to ultrasonic energy (FIG 20). Commercial ultrasonic cleaning equipment was used for this purpose. At a maximum power the generator output was 400 watts, and was coupled to a 25 kc magneto strictive transducer. A dummy run was made with only LOX in the stainless steel container to obtain the evaporation time (i.e., 10-15 minutes). Three runs then were made with two inch diameter test discs; one each of 0.010, 0.025, and 0.063 inch thickness for 15 minutes duration. No reactions occurred.

The ultrasonic energy levels under these test conditions undoubtedly are far higher than those used in liquid level detectors, and thus it might be inferred that ultrasonic level detectors are safe for use in titanium-LOX systems. While the test results are indicative, the sonic frequencies of cleaning and detector instruments are understood to be quite different and could affect the capability to initiate a

reaction. Thus, before actually employing an ultrasonic liquid level detector in LOX systems containing titanium, it would be advisable to make a simple test of the particular detector proposed for use in the intended service application before assuming that no appreciable hazard is present.

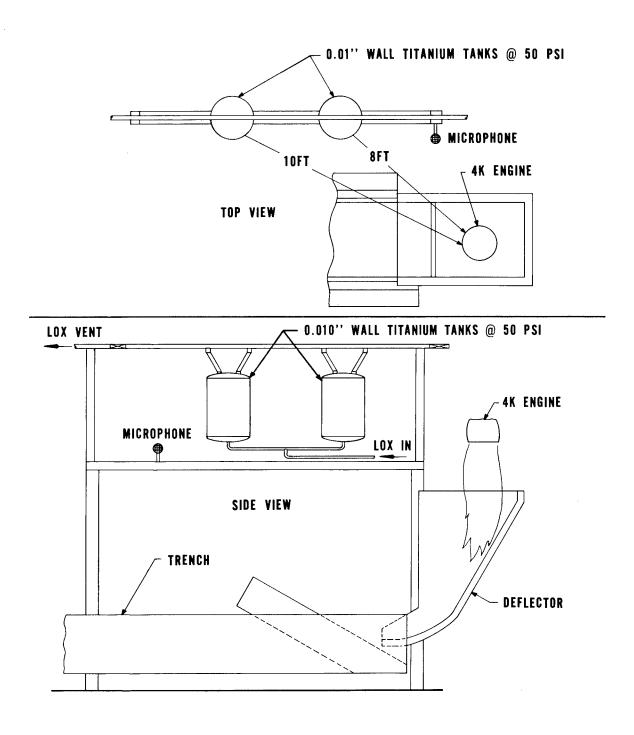
FIGURE 21. ACOUSTIC TEST SETUP (TITANIUM LOX TANK)

Two 0.010-inch wall titanium tanks filled with LOX were located about 8 feet from a rocket motor (FIG 21). A 4000-pound thrust liquid oxygen-kerosene rocket engine was fired to produce a 150 db acoustic pressure level. The titanium tanks were filled with LOX prior to each test and LOX evaporation was utilized to maintain a pressure of approximately 50 psig in the tanks.

Four tests were conducted with the LOX filled titanium tanks exposed to a nominal sound pressure level of 150 decibels. Three of these tests were of 60 seconds duration and one was of 30 seconds, for a total test time of 210 seconds. FIG 22 depicts the average sound pressure level for all of the tests at the two microphone positions shown in FIG 21. The tanks were not affected by these conditions.

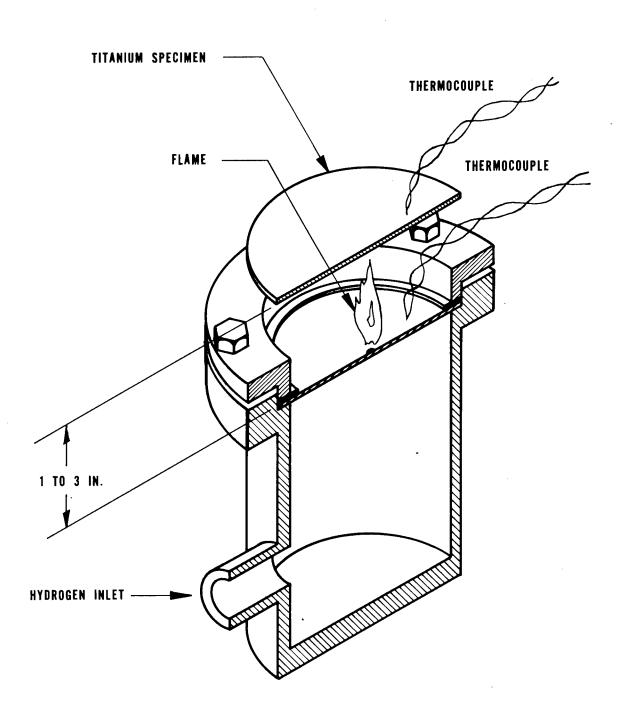
FIGURE 23. DIRECT IMPINGEMENT OF HYDROGEN/AIR FLAME ON TITANIUM

Tests were made to investigate whether direct impingement of hydrogen/air flames would ignite titanium in air. Laboratory type tests were made by modifying the titanium disc container fixture shown previously in FIG 17. A small hole (0.010-inch diameter) was drilled in the 0.010-inch titanium disc and a similar disc without a hole was placed parallel to the lower one and several inches directly overhead. A flow of gaseous H2, sufficient to maintain a pressure of 5-10 psig in the container, was begun and the escaping gas ignited by Upper surface temperatures of both discs were monitored by thermocouples (FIG 23). Four tests of approximately 10 minutes duration each were made, in which the spacing between the titanium plates were varied to obtain the highest temperatures. Under these test conditions, a spacing of one inch resulted in attainment of 1200°C (2200°F) on the top plate, and 980°C (1800°F) on the lower plate. The titanium was severely embrittled by these conditions, as would be expected, and a thin white powder coating formed on the surface (undoubtedly titanium dioxide). However, the metal did not ignite. Similar tests with 2014-T6 aluminum rather than titanium, produced melting (as expected) without appreciable reaction.

These results indicated that deleterious effects on titanium. by a hydrogen/air flame are much more likely to be structural weakening, i.e., embrittlement, than ignition.

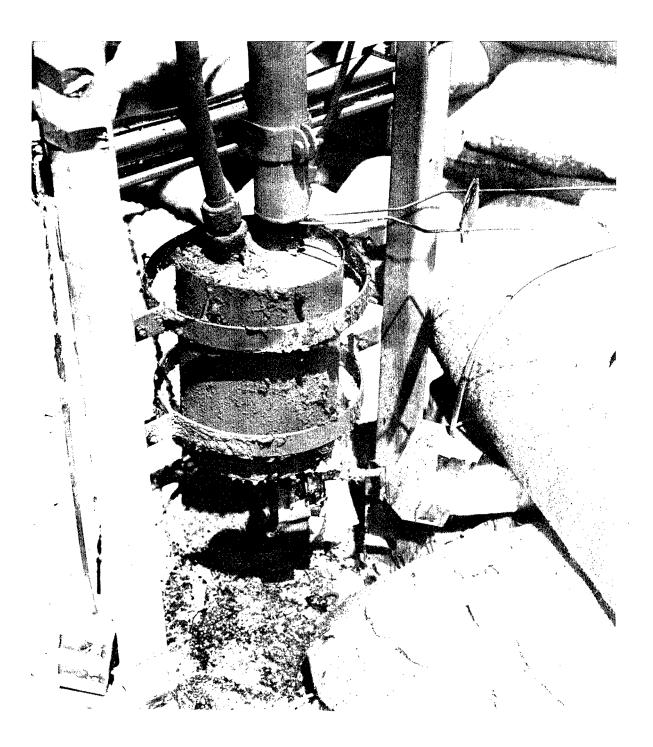
FIGURE 24B. LH $_2$ -TITANIUM TANK TEST AFTER PUNCTURE AND H $_2$  BURNING

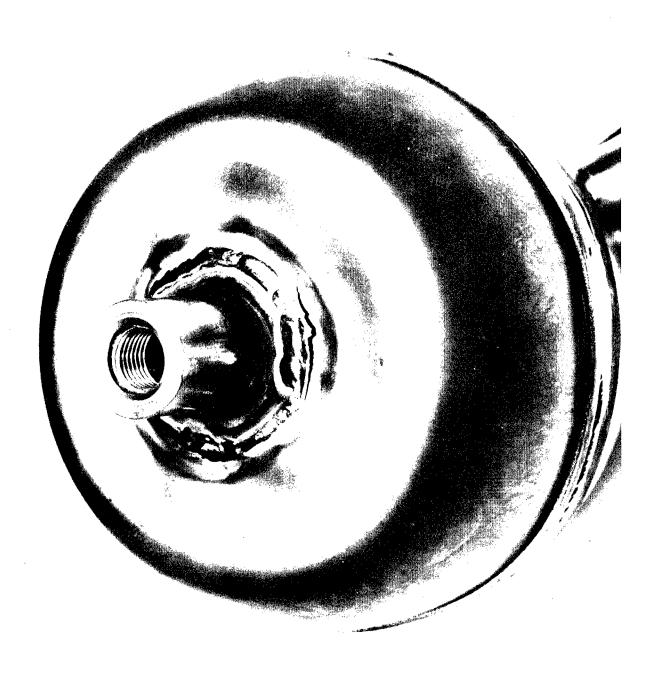
FIGURE 26. TITANIUM VESSEL FAILURE AT 125 PSIG O<sub>2</sub>-0.010 IN. WALL

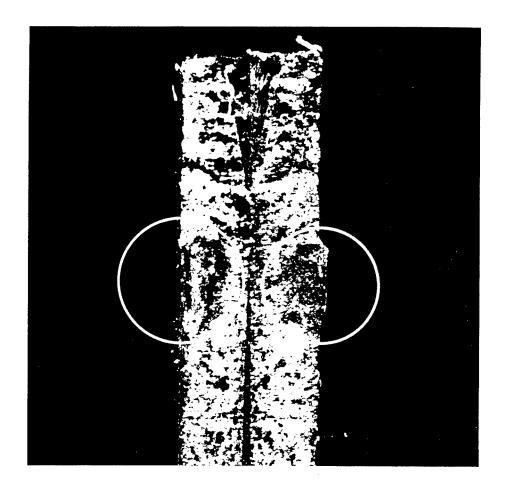
BOTH EDGES OF SAMPLE SHOWN IN FOLDED OVER POSITION

# FIGURE 27. "BURNT" SPOTS OF FATIGUE FRACTURED SPECIMEN

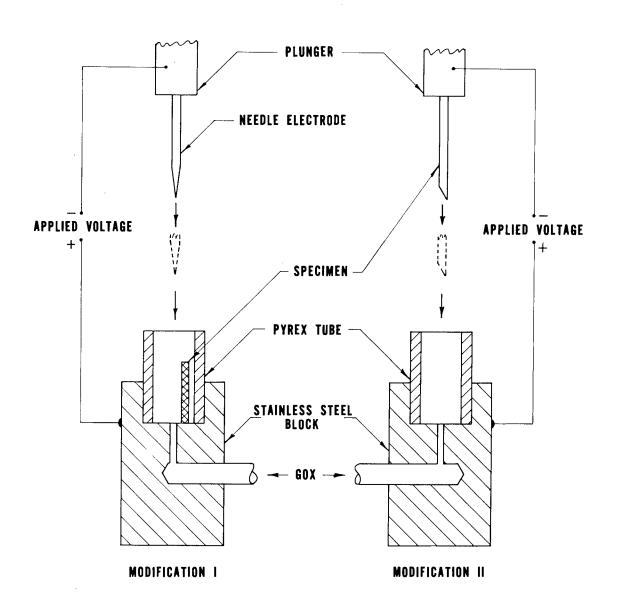
FIGURE 28. APPARATUS USED FOR SPARK SENSITIVITY TESTS

Results for titanium indicated that very low spark energies sufficed for ignition of samples of 0.005-inch thicknesses with somewhat larger energies required for thicknesses of 0.007 and 0.010 inch. The results were extremely variable, however, and appeared to depend on the extent of confinement, oxygen flowrate, point of impingement of the spark, and other variables. The results are therefore regarded as semiquantitative and only the range of spark energies for which ignitions were obtained (one to ten joules) is regarded as significant.

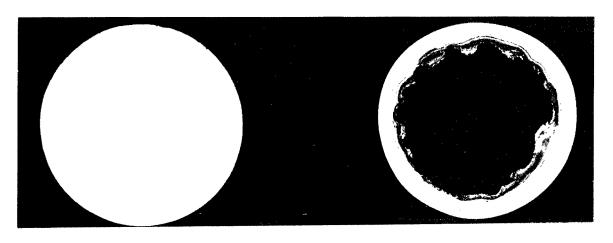
or rapid combustion of all of the exposed titanium (FIG 31). The detonations were accompanied by a very loud explosion which usually blew open the door of the test cell (friction latch). Detonations were much more frequent in the low temperature than in the room temperature tests. This may be due to a higher concentration of oxygen present.

FIGURE 31. TYPICAL APPEARANCE OF TITANIUM DIAPHRAGMS AFTER PUNCTURE TESTS

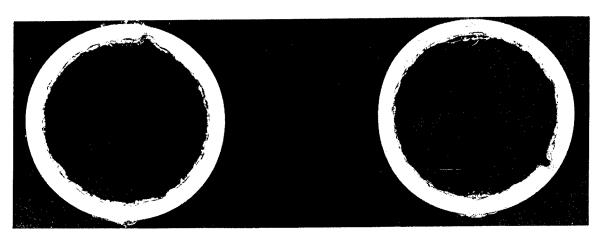
No reactions were obtained in 47 trials with two aluminum alloys (2014-T6 and 6061-T6) under a similar variety of test conditions. Comparative tests were made also with a type 301 stainless steel diaphragm (0.012-inch thick) at low temperatures. No reactions occurred in ten trials (FIG 32). Similar puncture tests with thin (0.006-inch) commercially pure aluminum at room temperature also failed to produce any reactions in four trials (Table 28).

FIGURE 32. TYPICAL APPEARANCE OF ALUMINUM AND STAINLESS STEEL DIAPHRAGMS AFTER PUNCTURE

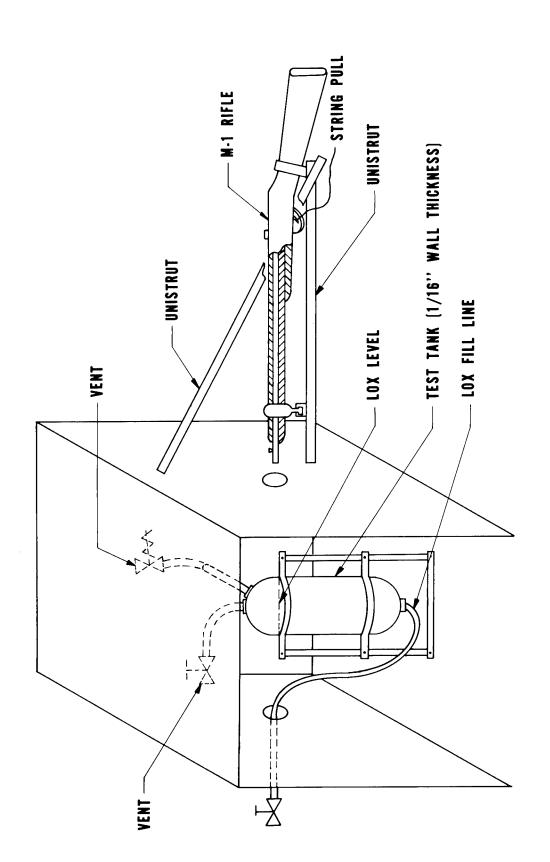
TANK PUNCTURE APPARATUS (M-1 RIFLE SETUP) FIGURE 34.

The most drastic puncture test used was penetration by a standard M-1 rifle bullet, i.e., caliber .30-06 bronze jacketed lead slug. The test setup is shown in FIG 34. The first test was made with the aluminum tank. No reaction occurred. The bullet penetrated both sides of the tank, leaving clean holes.

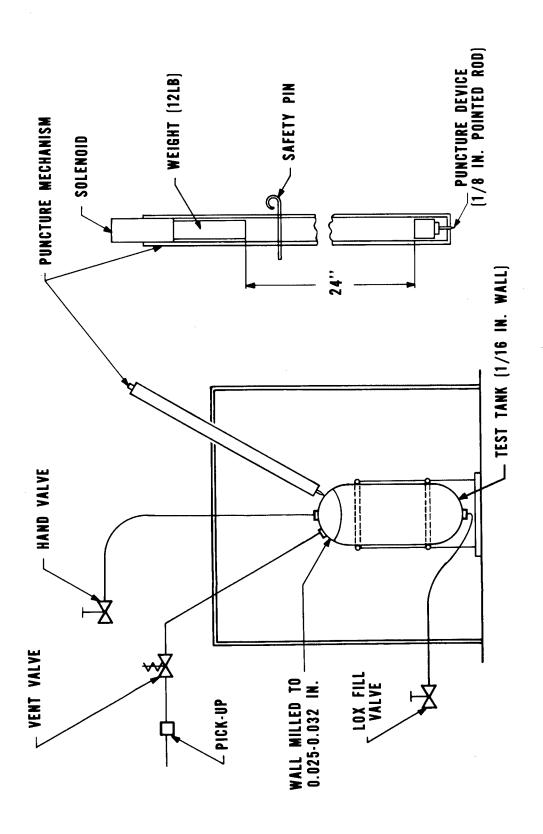
TANK PUNCTURE APPARATUS-PIN TYPE TEST SETUP FIGURE 36.

An aluminum tank was tested first and again failed to react on puncture. In the first pin test on the titanium tank, the puncture self-sealed and no reaction occurred. In order to provide some information on the initiation of reactions in tanks by shock conditions, a 10-inch length of 40 gr/ft Primacord was taped to the side of this container. (None of the previous shock sensitivity tests were made with tanks.) The tank was refilled with LOX and was being pressurized when an explosion occurred spontaneously. The Primacord had not been set off at the time. It is suspected that the pin may have been jarred loose during pressurization and the escaping gas ignited the titanium. High speed camera coverage of this explosion disclosed the same delayed detonation process as occurred in the bullet puncture. The explosions from both tanks were of the same relative degree of blast intensity. The remains of this tank were similar to those of the previous test.

Another pin puncture test was made using a titanium tame in which the top head was replaced by a 0.025-inch flat sheet. An explosion and delayed detonation again occurred.
